Danish Atomic Energy Commission  
Research Establishment Risö

A PERFORMANCE TEST OF WOOD-PLASTIC  
PARQUET FLOORING

Klaus Singer and Arne Vinther

August 1972

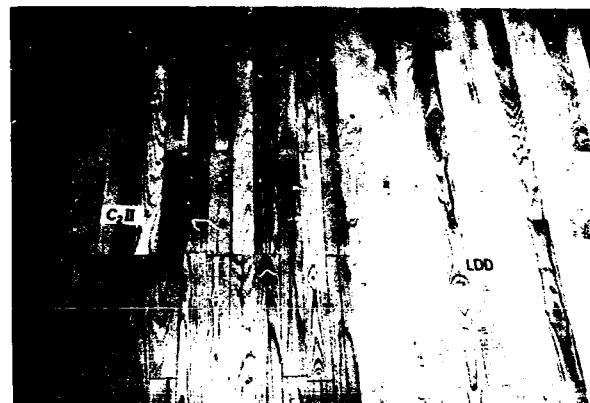
Right from the beginning of the testing some thin cracks in the longitudinal direction were observed in some of the face strips, especially in those containing polymethylmethacrylate (fig. 7a + b). These cracks probably occurred during the polymerization reaction. They did not increase in size or in number later on, but they became more visible because dirt gathered in them.

Fig. 7a. Crack formation in PMMA-impregnated ash strips (C<sub>2</sub>II).  
LDD is a non-impregnated lacquered reference panel.
